<h1>ENGINEERING SUMMARY REPORT</h1>	Report #	ESR-9553
	EWOM #	N/A
	CLT #	N/A
<p>Evaluation of RVPX product line to VITA 46 standards</p>	Revision #:	3
	Publish Date	
	3/8/2016

Testing was performed on Amphenol's R-VPX Ruggedized VITA 46 connector to determine its conformance to the requirements of VITA 46. Testing also included intermatability with current VITA 46 compliant connectors offered by another connector manufacturer.

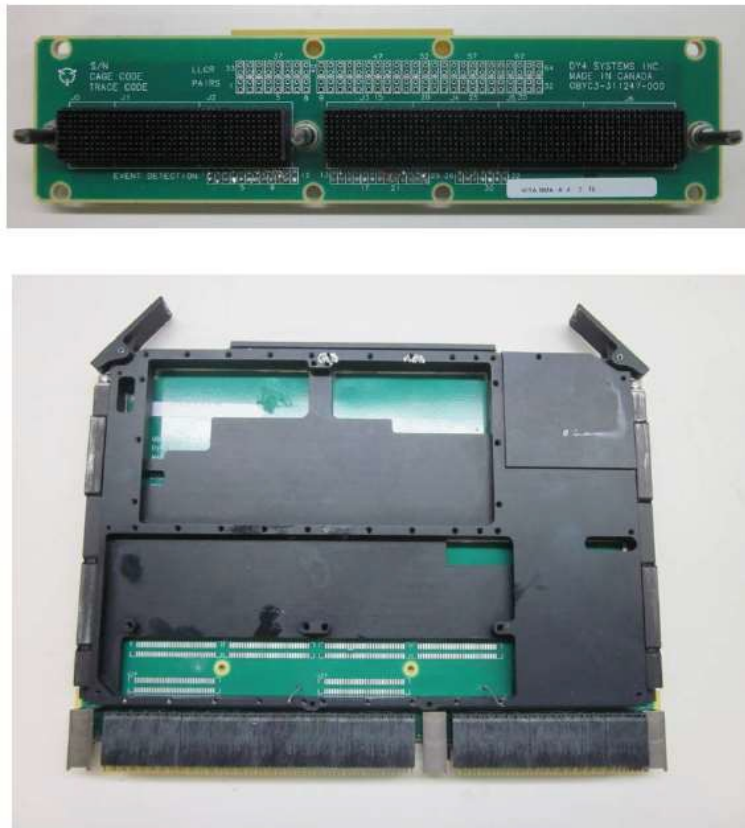
Figure 1: Typical Test Sample

Test specimens were representative of normal production lots. Specimens identified with the following part numbers were used for test

Sample	Part Number	Description
VITA 46 6U Daughtercard Amphenol	RVPX-P08VM2	Right angle daughtercard 8 pos. end
	RVPX-P16DM2	Right angle daughtercard 16 pos. center
	RVPX-HMM6	Right angle daughtercard guide module
VITA 46 6U Backplane Amphenol	RVPX-J08EM2	Vertical receptacle backplane 8 pos. end
	RVPX-J16MM2	Vertical receptacle backplane 16 pos. middle
	RVPX-J16EM2	Vertical receptacle backplane 16 pos. end
	RVPX-HPM-2	Keyed guide pin machined
VITA 46 6U Daughtercard		Right angle daughtercard 8 pos. end
		Right angle daughtercard 16 pos. center
		Right angle daughtercard guide module
VITA 46 6U Backplane		Vertical receptacle backplane 8 pos. end
		Vertical receptacle backplane 16 pos. middle
		Vertical receptacle backplane 16 pos. end
		Keyed guide pin machined

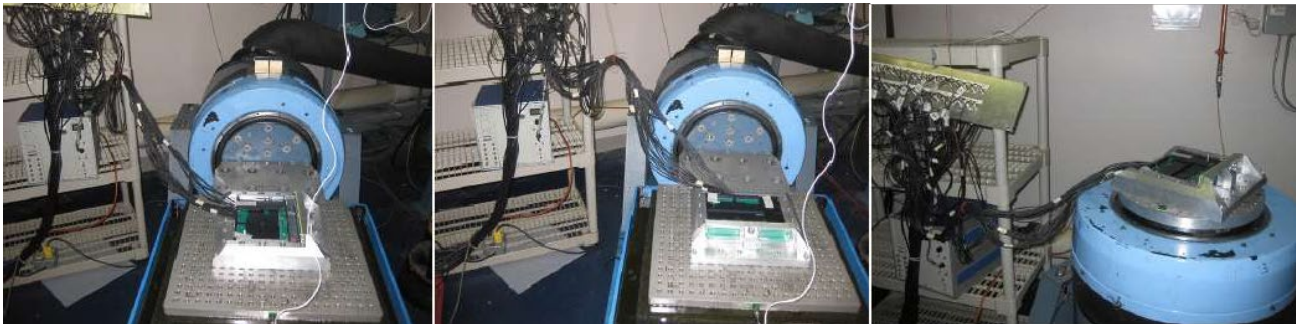
Figure 6: Vibration test set-up

4.5.1. Samples were subjected to a 10 minute sine vibration sweep of 5 g between 50 and 2000 Hz to identify their resonant frequencies and transmissibilities. Response accelerometers were located at the areas of highest displacement/acceleration of the first 3 vibration modes, e.g. center of middle rib. The frequency and transmissibility data was compared to data from typical 6U x 160mm conduction cooled product to ensure similarity.

4.5.2. Samples underwent different random vibration tests, according to MIL-STD-1344A, Method 2005.1. The first sample was tested to Test Condition V, letter D (0.1 G²/Hz max., 1.5 hours per axis) as a minimum requirement of VITA 46. The second sample was tested to further explore the connector capability. The vibration level was applied as a step stress, i.e. 0.125 G²/Hz for 15 minutes, 0.15 G²/Hz for 15 minutes, 0.175 G²/Hz for 15 minutes, and 0.2 G²/Hz for 45 minutes, for a total duration of 1.5 hours.

No discontinuities were detected during vibration testing. Following vibration testing, no cracks, breaks, or loose parts on the specimens were visible.

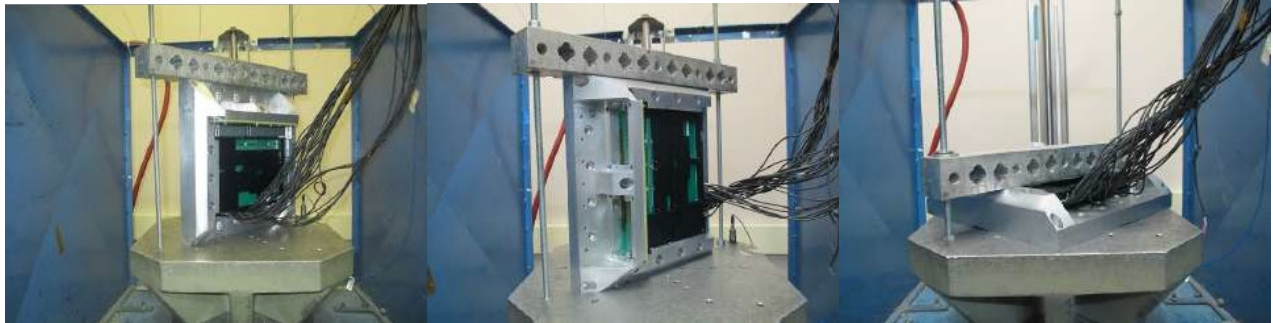
Figure 7: Mechanical Shock test set-up

Each sample underwent shock following MIL-STD-1344A, Method 2004.1, Test Condition A (1/2 sine, 50 g in perpendicular axis, 80 g in other axes, 11 ms, 3 hits from both directions in each of 3 mutually perpendicular axes for a total of 18 hits).

No discontinuities were detected during mechanical shock testing. Following mechanical shock testing, no cracks, breaks, or loose parts on the specimens were visible.

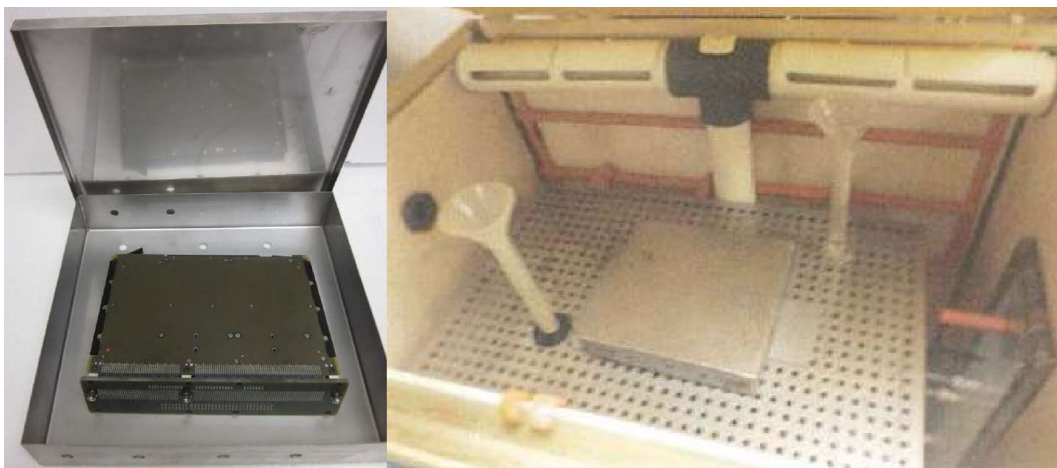
Figure 8: Salt Fog with SO₂ test set-up

One Group D sample underwent Salt Fog with SO₂ per ASTM G85 (Annex A4, Cycle A4.4.4.1). The test sample was exposed in the mated condition in a sheet metal container.

No evidence of physical damage was visible as a result of exposure.
