Intel[®] I/O Controller Hub 6 (ICH6) Family

Specification Update

Order Number: 301474-030

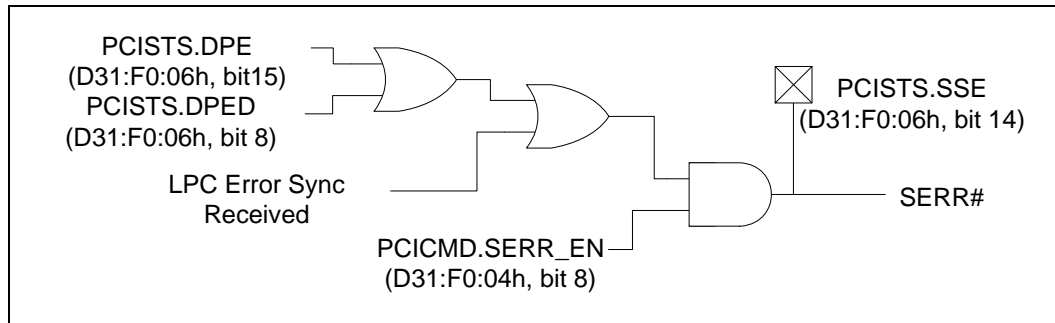
Figure 1. LPC Bridge SERR# Generation

The first class of errors is parity errors related to the backbone. The LPC Bridge captures generic data parity errors (errors it finds on the backbone) as well as errors returned on the backbone cycles where the bridge was the master and parity error response is enabled. If either of these two conditions is met, and with SERR# enable (PCICMD.SERR_EN) set, SERR# will be captured.

Additionally, if the LPC Bridge receives an error SYNC on LPC bus, an SERR# will also be generated.
