Debugging a Mixed Signal Design with a Tektronix Mixed Signal Oscilloscope

Application Note

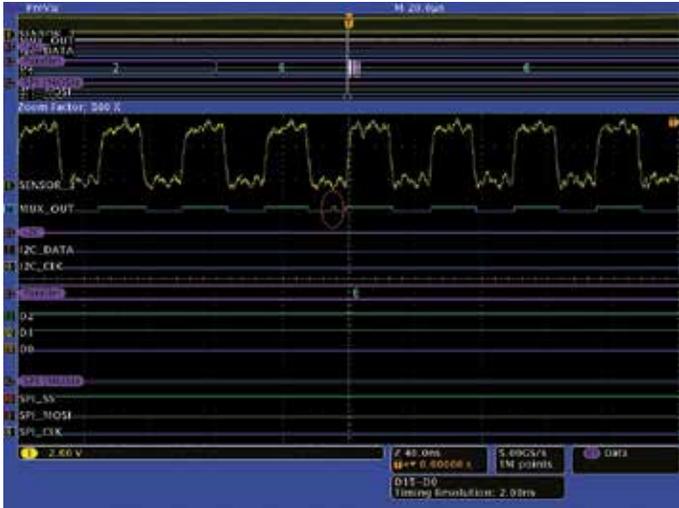
Figure 6. Wave Inspector® reveals a glitch on the MUX_OUT signal.

Figure 6 shows the timing correlation between the analog and digital channels in the MSO/MDO Series. The input to the MUX is displayed on CH1 (SENSOR_3) while the MUX output is observed on digital channel D14 (MUX_OUT). The engineer noticed that although the MUX output had a glitch, the input to the MUX appeared glitch free. After identifying the glitch with the digital channel, the engineer decided to take a closer look by connecting CH2 to the MUX output. Figure 7 shows the resulting acquisition with the oscilloscope still configured to trigger on the parallel bus value 0x7. The waveforms for the SPI and I²C buses have been turned off in Figure 7 to focus on the primary signals of interest. Using the analog probes on the MUX input and output revealed that glitches present on the output are not present on the input signal. Figure 7 shows that a glitch on the MUX_OUT signal appeared a short time before
